RESEARCH NOTE

CENTRAL STATES FOREST EXPERIMENT STATION

CS-7

USE AIR-DRY DECKBOARDS FOR BETTER WOODEN PALLETS

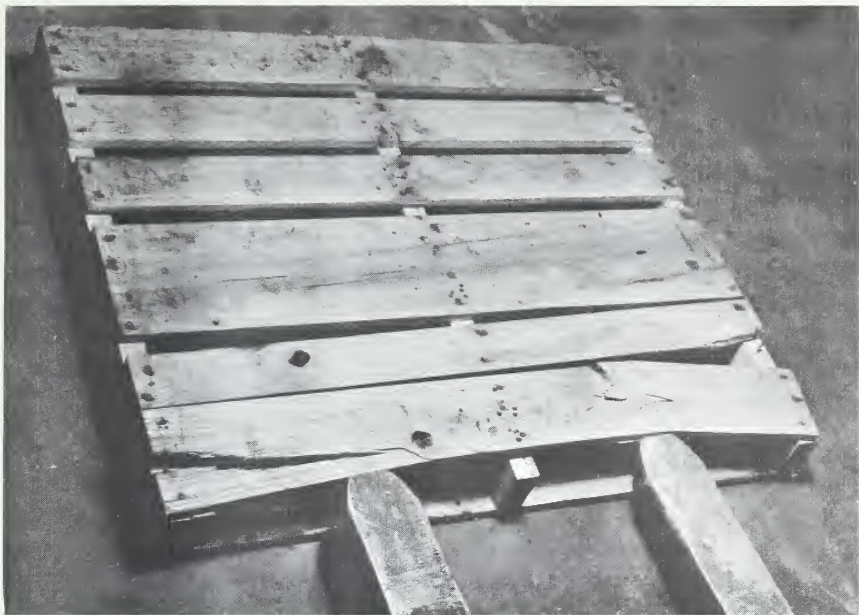
The 90 pallets are being used in the apple-processing plant of Eckert Orchards, Incorporated, Carbondale, Illinois. During the first year of the test, the plant operated intermittently for a total of 165 days and the pallets were moved an average of 0.6 times per day. Six pallets were accidentally damaged when rammed by lift-truck forks. Breakage in these pallets was confined to top edge deckboards and, in two cases, to an adjacent top deckboard (fig. 1). These pallets were repaired and placed back in service.

Figure 1.--A typical accidental ramming failure.

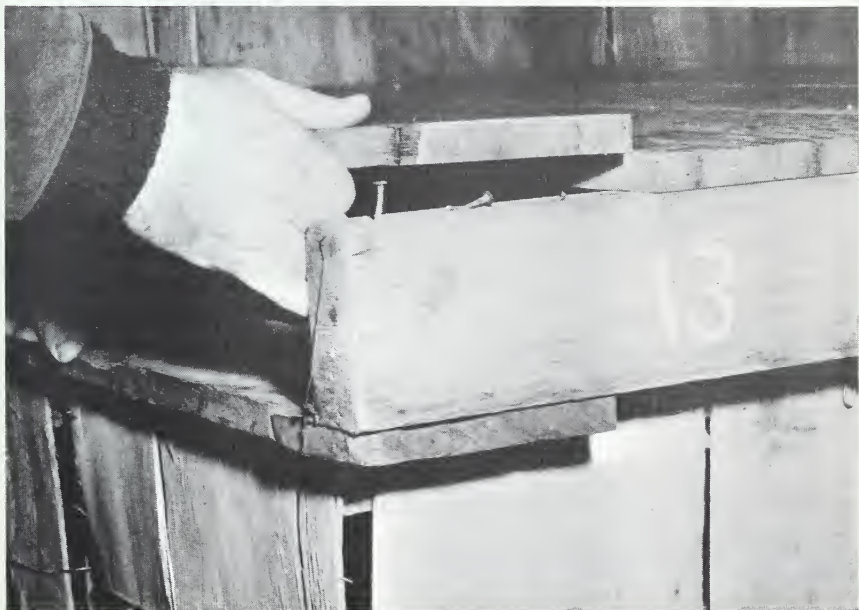
Excluding the accidental damage, ten pallets failed during normal use. Eight of these were all-green pallets, one was an all-dry pallet, and the other was a dry-green pallet. Failures consisted of complete separation of a top edge deckboard from one or more stringers due to nails either pulling through the deckboard or shearing off (fig. 2). In no case did a nail pull out of a stringer.

Failures resulted primarily from the prying action of lift-truck forks and appeared to be closely related to splits or through-checks at the nails. There were four times as many splits or through-checks at the nails in green deckboards as in dry deckboards.

When the edge deckboard was split or checked at the nails, the nails most often bent or pulled through the deckboard. If the deckboard was not split or checked, the nails usually sheared off between the stringer and the deckboard. The type of nail failure also depended on the location of nails in edge deckboards: nails closest to the leading or front edge of the deckboard most often pulled through, while those nearest the trailing or back edge of the deckboard usually sheared off (fig. 2). Failure of nails at the center of the 5 1/2-inch-wide edge deckboards was about equally divided between pull-through and shearing. It appeared that when splits were present at the nails in edge deckboards, the prying action of the lift-truck forks caused the leading edge nails to begin pulling through the deckboard. The resulting increased load on the trailing edge nails tended to shear them off. Since splits were more prevalent in green deckboards, this failure happened most often in pallets fabricated with green decks.

Figure 2.--A typical normal use failure.

A comparison of failures in the test pallets during the first year of use indicates that the advantages of using air-dry lumber for deckboards might well offset the added initial cost of pallets with dry decks. Except for minor nail-popping, there was no noticeable difference in pallet performance due to initial moisture content of stringers, but this factor might become important with further use. Pallets with loose deckboards were repaired and returned to service. We will continue to observe and record performance through at least one more season of use.
